Analysis of Brownfield Cleanup Alternatives

Asbestos Abatement of Two
Redevelopment Properties at 1500 Martin
Luther King Jr Boulevard and 3400
Holmes Street,
Dallas, Texas 75215

August 28, 2025

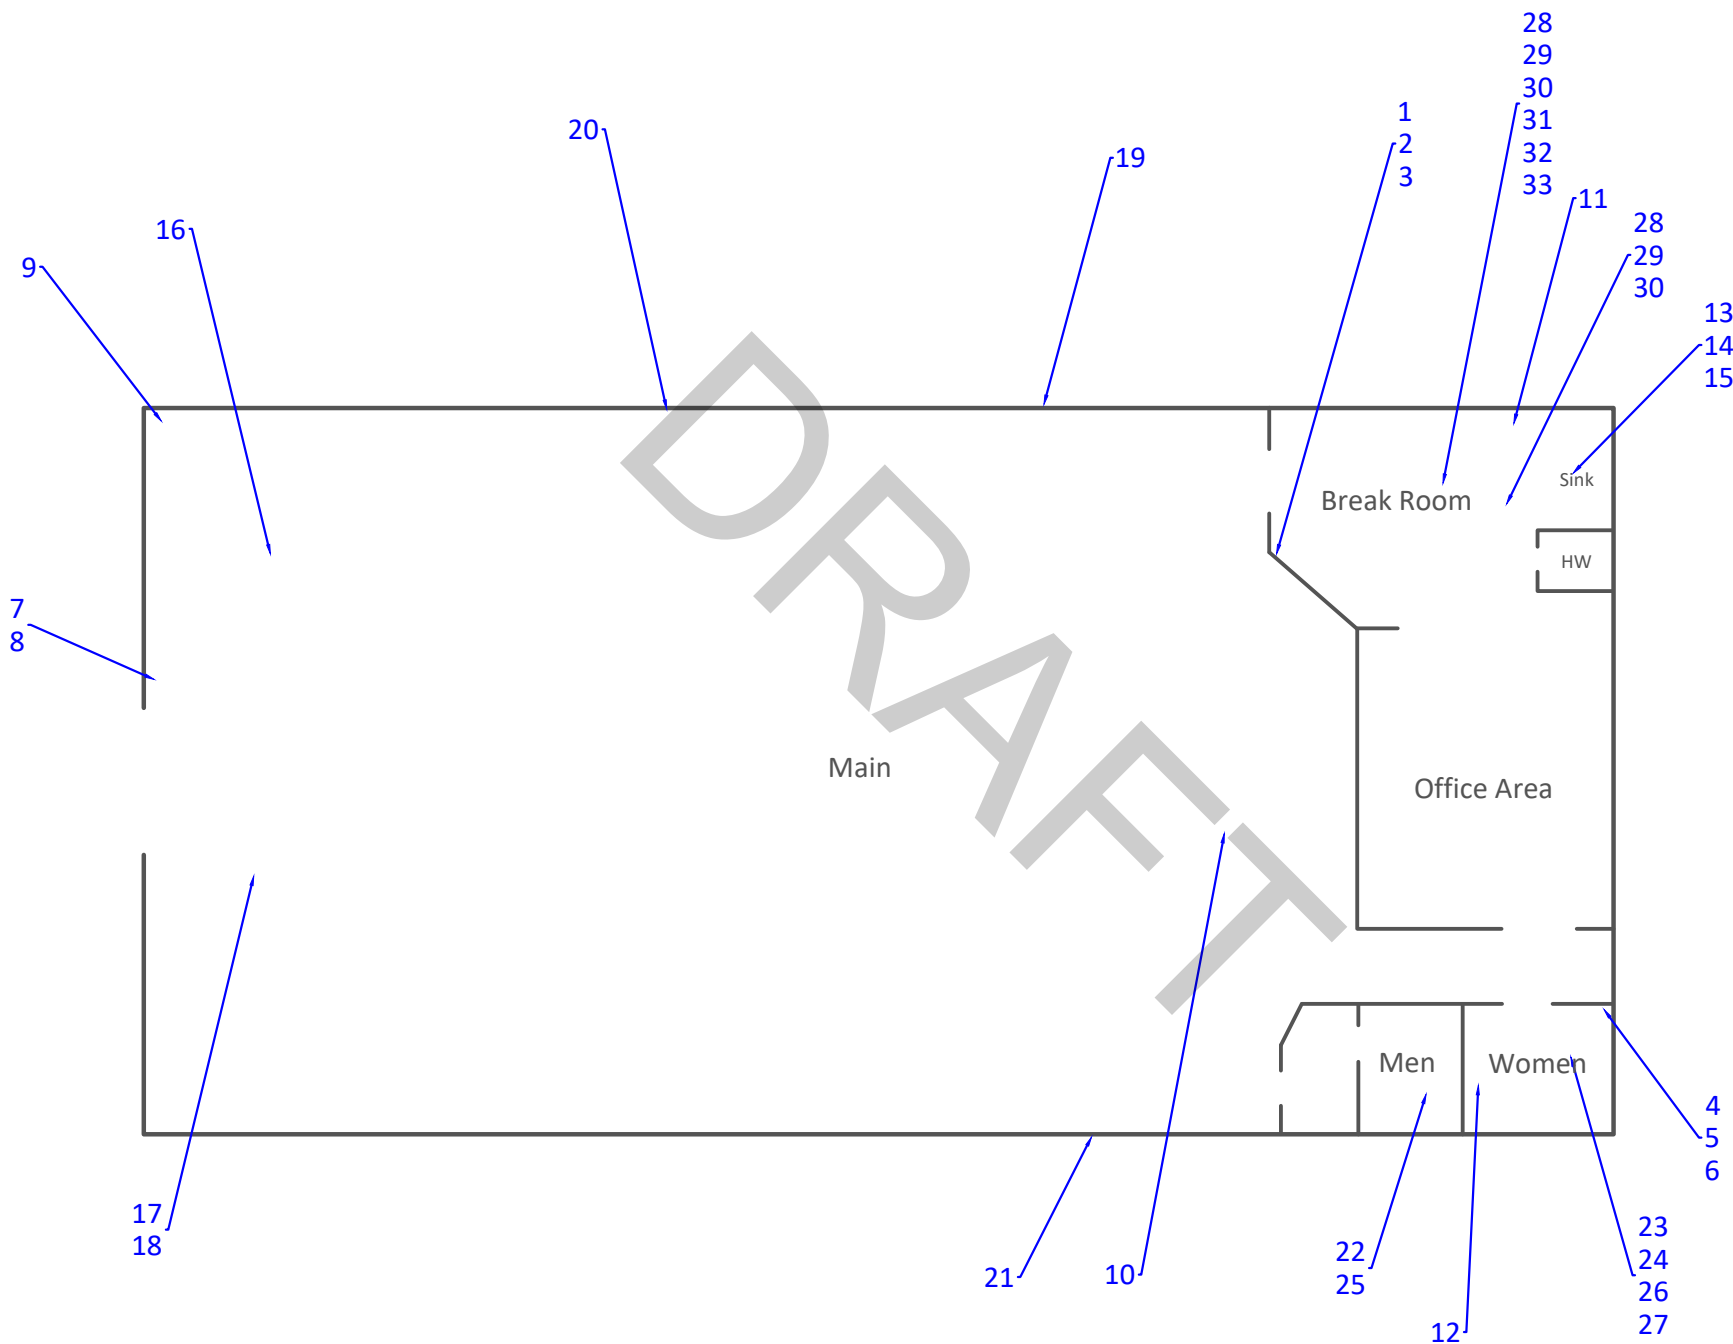
Figure 1

**Sample
Location
Plan**

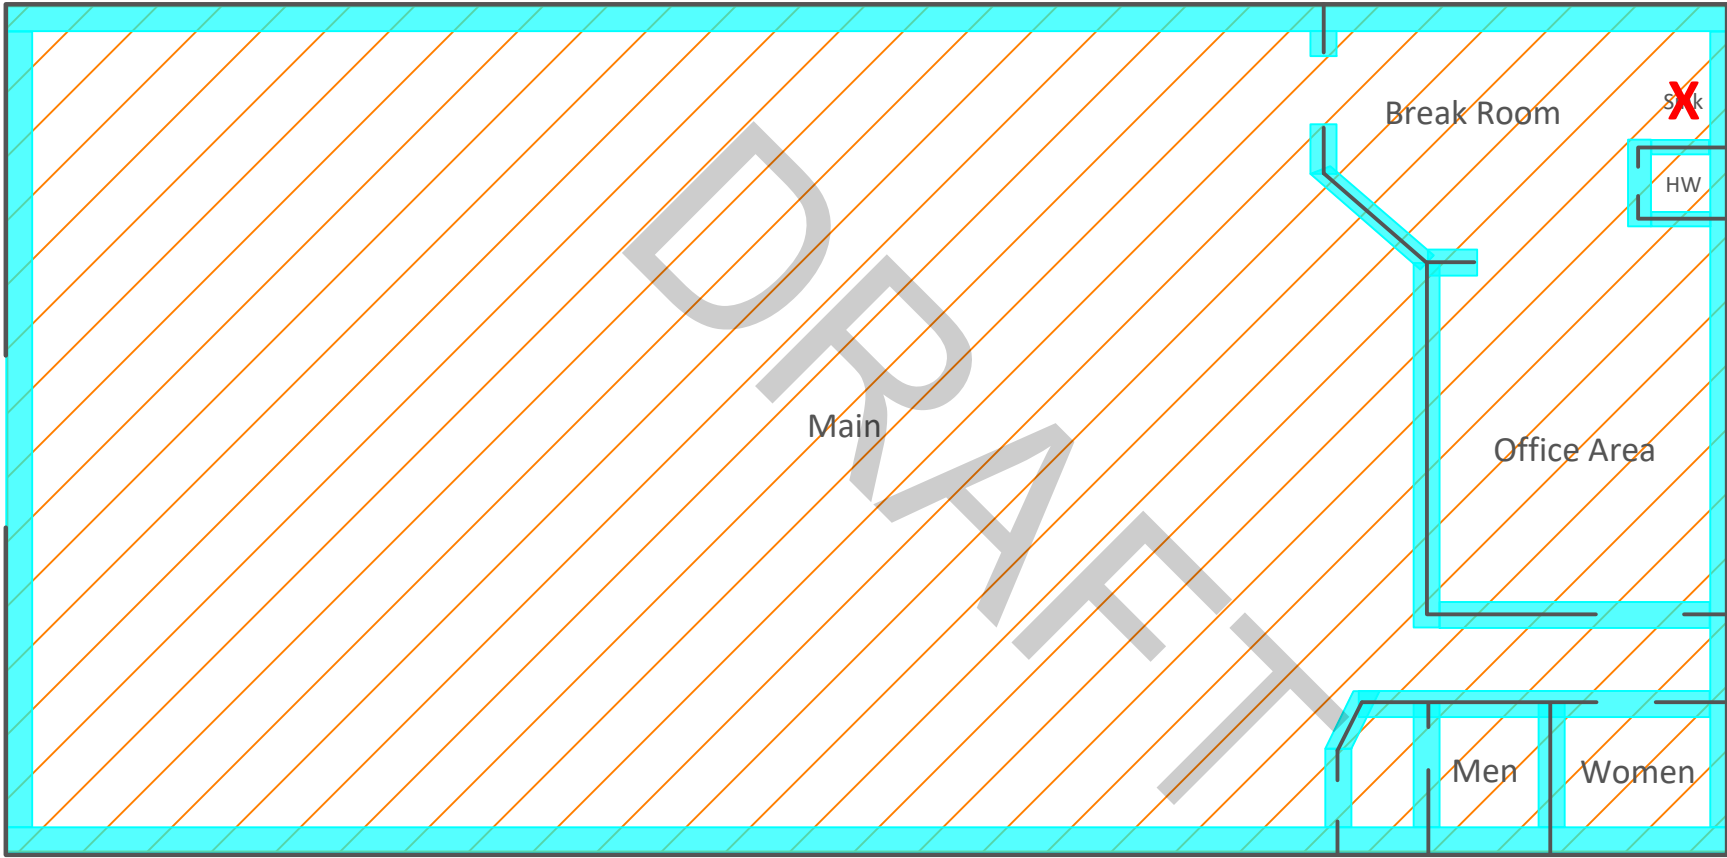
Figure 2

**ACM
Location
Plan**

Asbestos Containing Material (ACM) Ceiling Texture
